Castor

Built Environment Audit 2002/2004

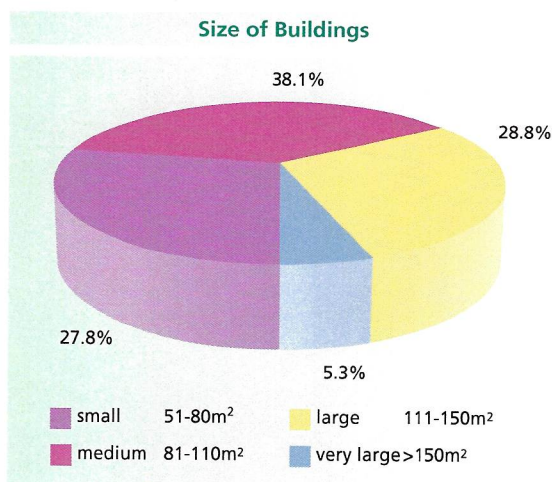
Total Number of Buildings – 320

Over a third (38%) of all buildings are medium sized (with three bedrooms or equivalent), 29% of properties are large and a further 5% are very large. The remaining 28% of buildings are small, (having one or two bedrooms), with a ground floor footprint of 51-80m².

Modern estates give uniformly sized houses, medium and small, whilst the historic core has a varied distribution of sizes with large and very large buildings lying on or set back from the main village street. The buildings are grouped close to the core or, in the case of Village Farm and Castor House, positioned respectively at the west and east entrances to the historic village.

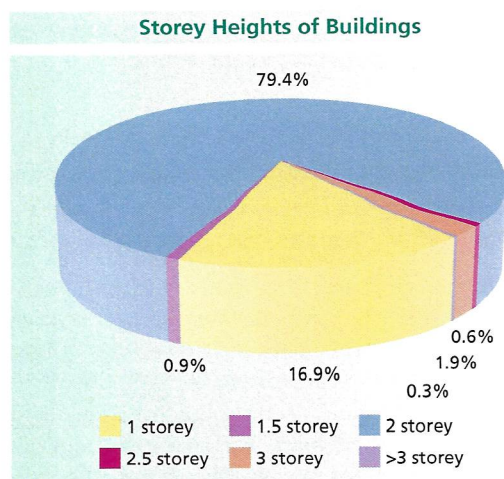
Total Number of Buildings - 320

The great majority of buildings (79%), have two storeys. This basic categorisation disguises the fact that two storey buildings from different periods have different room heights and hence verge levels, varying plan depths, roof pitches and ridgelines. There is, therefore, significant variation within this category, at least for buildings pre-dating the introduction of the Building Regulations and standardisation of floor to ceiling heights.

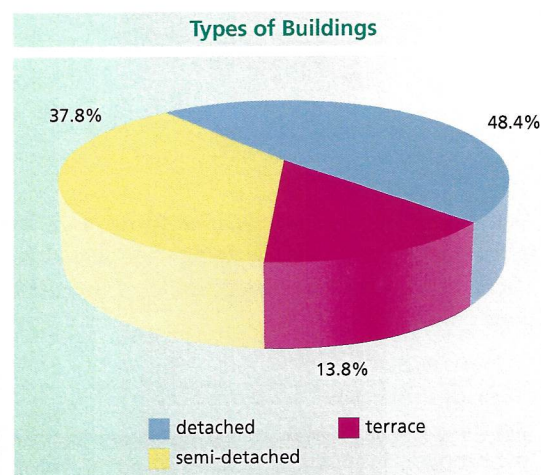
Total Number of Buildings - 320

Almost half the village's buildings are detached. There are two cottage terraces in Peterborough Road and Allotment Lane and modern terraces around St Kyneburgha Close. The semi-detached properties are almost all as a result of twentieth century estate developments in Sylvester Road and Benams Close, as is clearly illustrated on the map.

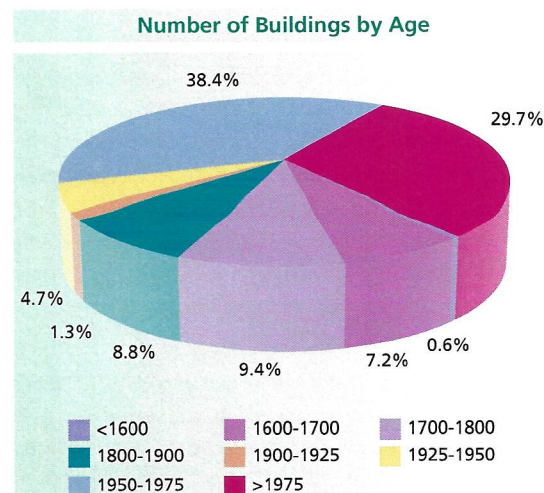
Total Number of Buildings - 320

The majority of buildings in Castor date from the modern era, with a total of two hundred and thirty nine built in the twentieth century, two hundred and twenty of these from 1950-2000.

A total of eighty properties date from <1600-1900. Of these, a significant number (twenty four) date from 1600-1700 and twenty nine from between 1700 and 1800.

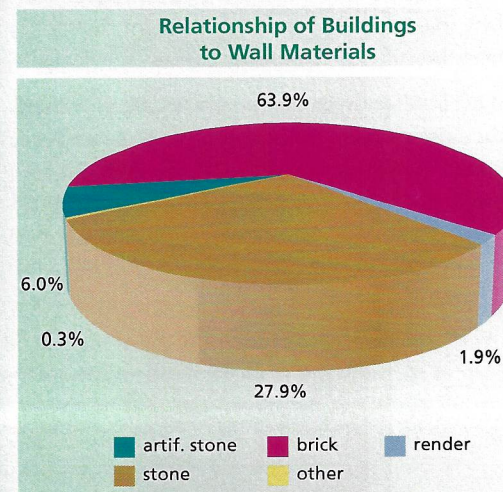
Total Number of Buildings - 320

Although modern brick buildings are most numerous, over a quarter of all the buildings in Castor (28%) are built in stone

When wall materials are mapped it becomes easier to understand the character of the village, with the core and Peterborough Road dominated by stone buildings and the brick buildings generally situated on the settlement edges. There are very few rendered properties in the village. Numbers 52-54 Peterborough Road and 14 Allotment Lane are examples. Old brick buildings, similarly, are rare in the village, which is not surprising given the plentiful supply of stone throughout its history.

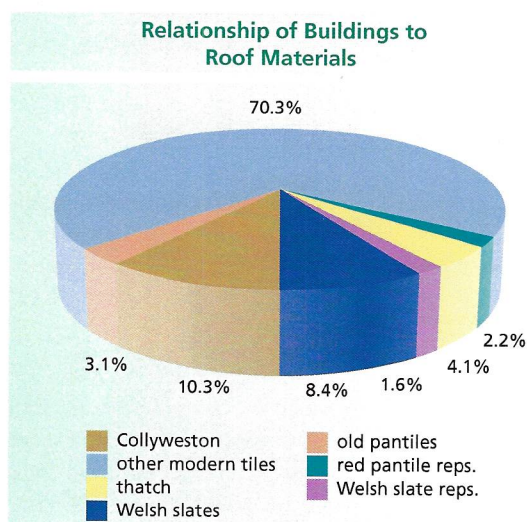
Total Number of Buildings – 320

In total, seventy four buildings are roofed with traditional materials, eight with replicas and two hundred and twenty with modern tiles. Traditional roofing materials (in total), account for nearly a quarter of the total roofing materials within the village.

The distribution map demonstrates the close and predictable correlation between wall materials and roof materials, the stone buildings being roofed mostly with traditional materials. Buildings roofed with traditional materials follow the age distribution pattern, along Peterborough Road and the Church Hill, High Street core.

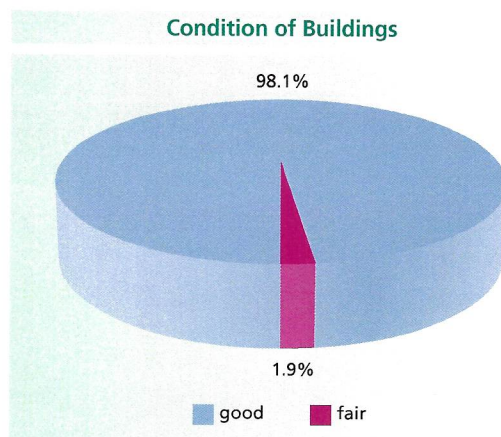
Total Number of Buildings – 320

As the chart clearly shows, the majority of the buildings in the village are classed as being in good condition. There are no buildings classed as being in a poor or very poor condition.

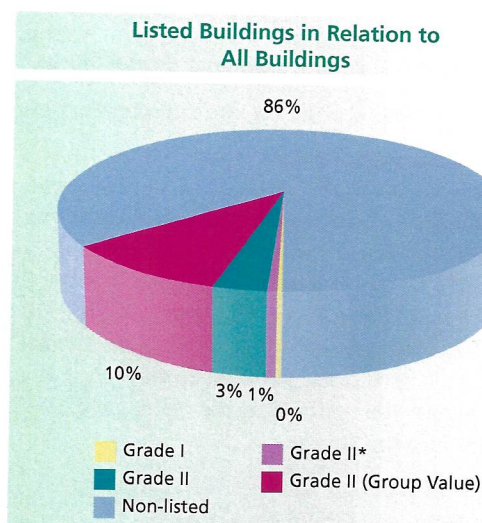
Total Number of Buildings - 320

There is one Grade I listed building in Castor, the church, two Grade II*, "Durobrivae" on the east side of The Green and Castor House. Forty listed buildings are classed as Grade II. In addition, there are structures such as barns and outhouses, which are listed separately but in the Audit database are included in the same address as the main building, leading to an undercounting of the total of listed buildings. There are actually fifty two buildings within the village envelope listed separately. Castor also has some listed structures other than buildings, notably the base and remaining part of the shaft of a village cross on the triangle of land in Clay Lane, which is listed as Grade II, a pump at "Durobrivae", Grade II*, a mounting block at The Cedars, Grade II, and the Dovecote to the west of Village Farm, Grade II Group Value. Due to the difficulty of identifying these structures on the database, they were not included in the initial survey, important though they are.

The percentage of listed buildings and structures (14%), demonstrates the importance of the village as a historic settlement. The listed buildings are distributed throughout the old parts of the village.

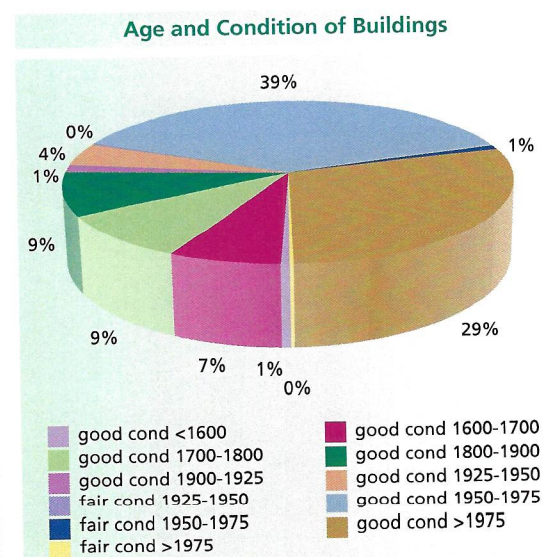
Analysis by Age and Condition

The majority of buildings of all ages are classed as being in good condition. There are no buildings in poor condition or at risk from dilapidation or dereliction.

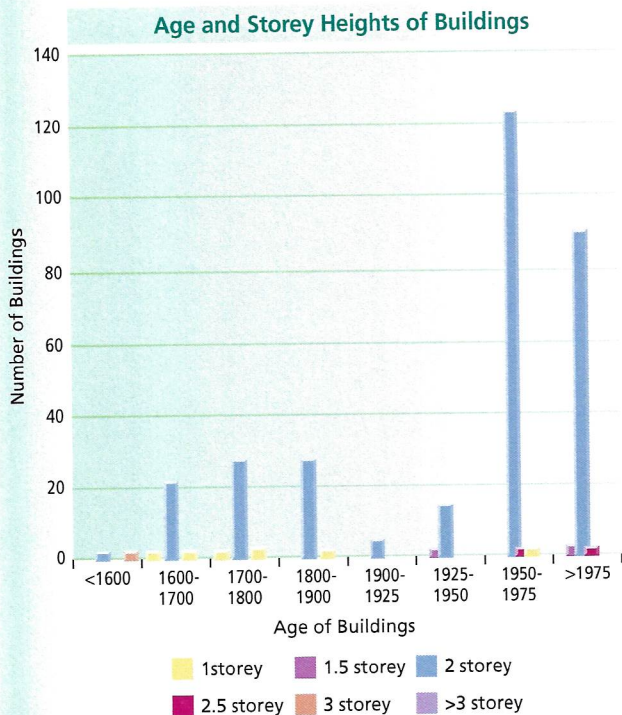
Analysis by Age and Storey Heights

The majority of buildings are two storey and were built between 1950 and 2000.

Bungalows are only found in the 1925-2000 period.

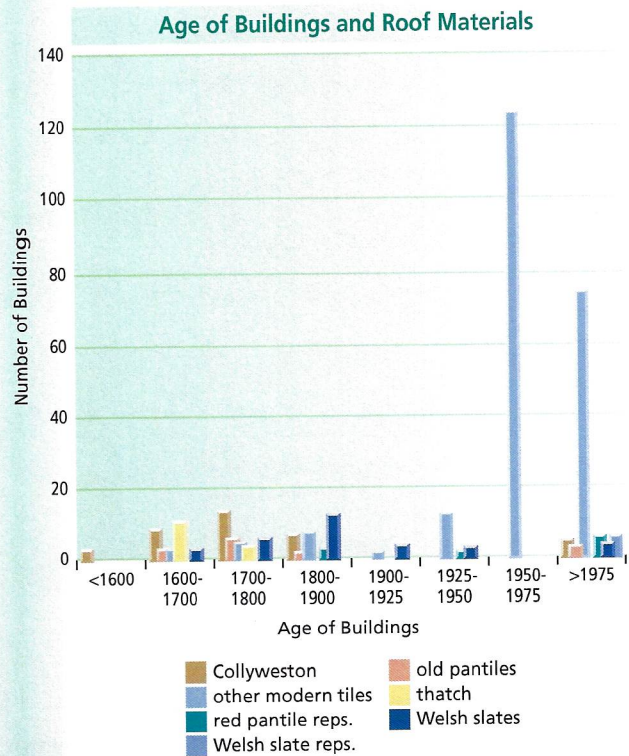
Analysis by Age and Roof Materials

The palette of natural roofing materials in the pre-twentieth century period is very striking and the overwhelming preponderance of modern concrete tiles after 1925 even more so. It is interesting and encouraging to see the return of traditional materials since 1975, probably as a result of greater emphasis on conservation and design following the introduction of the Department of the Environment Circular 23/77, *Planning and the Historic Environment*.

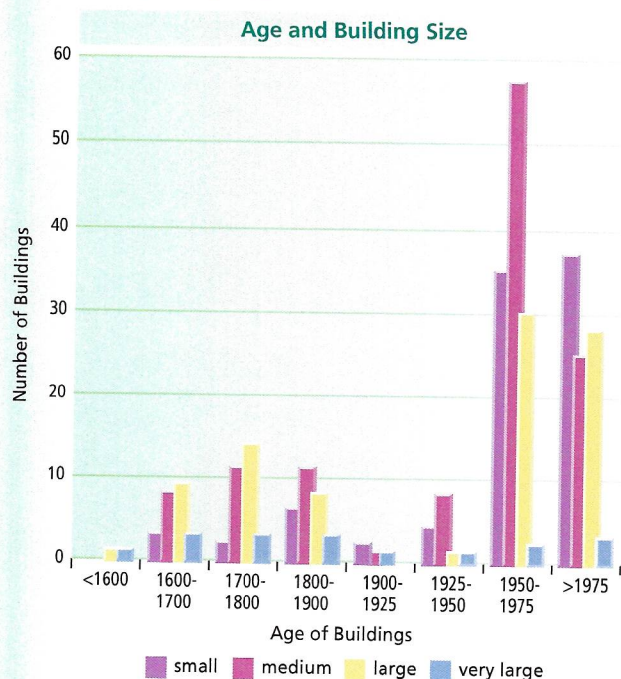
Analysis by Age and Size

For the purpose of this graph, size is taken as the building footprint. The distribution of buildings clearly shows the post 1950 building boom. Between 1950 and 2000, two hundred and sixteen properties (of all sizes) were built in Castor – the busiest period of construction by far.

The chart shows that medium sized buildings are now the largest category, but it is only recently that they have become so. Before 1800, there appeared to be more large buildings.

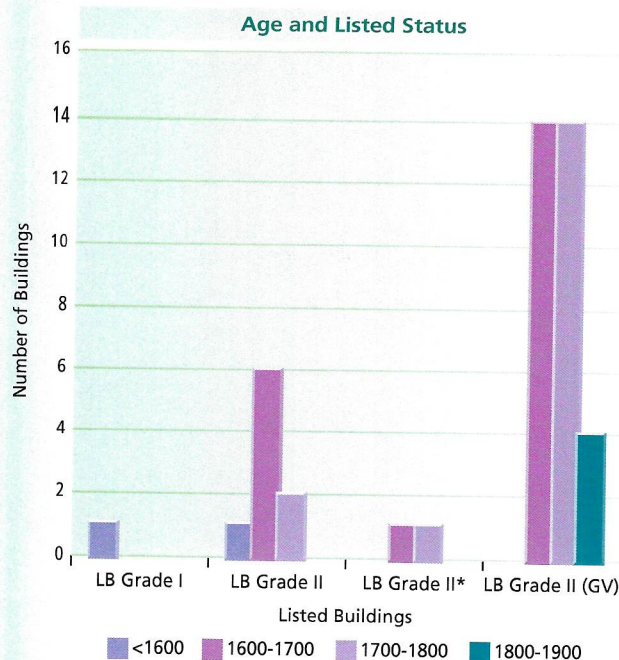
Total Number of listed buildings – 44

The church is the only Grade I listed building.

There are two Grade II* buildings, "Durobrivae", and Castor House, the gates of which are separately listed as Grade II* but not counted as a building in the Audit statistics.

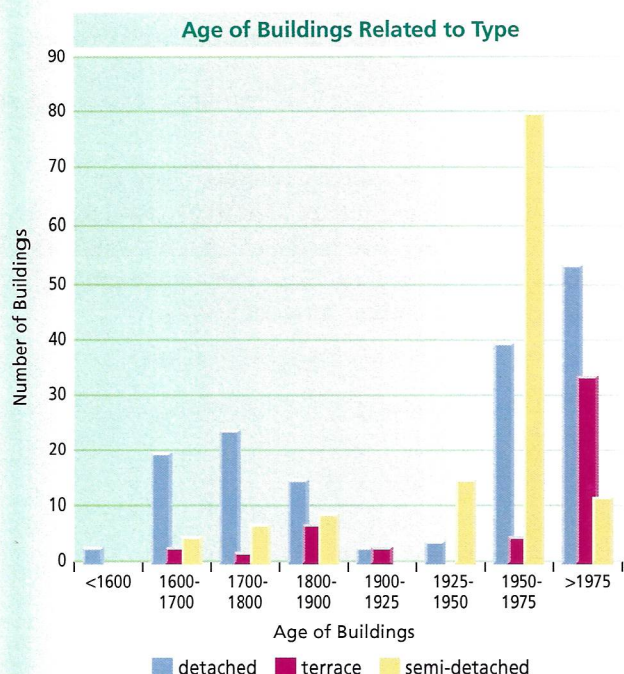
Analysis by Age and Type

Detached properties are the dominant built form in Castor. 45% of all houses are detached, the most prominent form in all periods.

Semi-detached properties are mostly attributable to the period 1950-1975, (24% of all buildings). This is the largest figure for any type of property built within any one period and reflects the 1960-1970s estate housing boom.

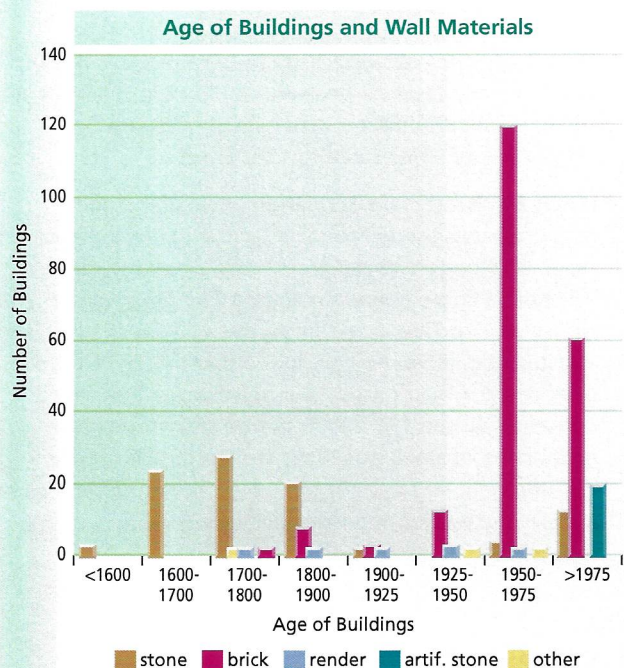
Analysis by Age and Wall Materials

The major housing growth of the village took place between 1950 and 1975, with one hundred and sixteen properties constructed almost entirely in modern brick. In the same period, only three properties were built of stone, one from re-used old bricks and one rendered.

Until the 1900s, stone was the material of choice. There is one stone building, excluding the church, that predates 1600. Between 1600 and 1700, twenty one stone buildings were built, twenty three between 1700 and 1800 and fourteen between 1800 and 1900.

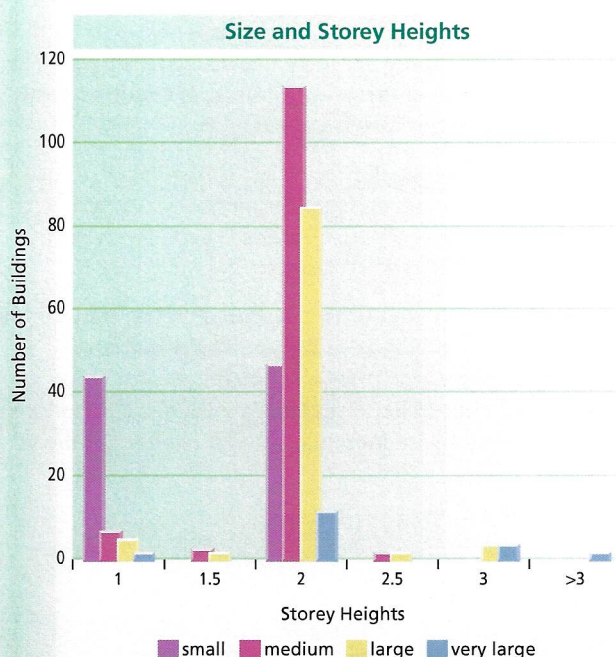
Analysis by Building Size and Storey Heights

The above analysis confirms that two storey buildings are by far the most dominant form with small single storey buildings, mainly comprising the twenty bungalows on Sylvester Road, the next largest group.

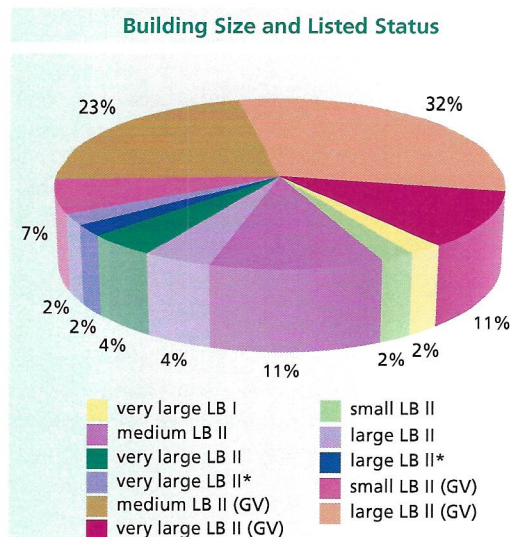
Analysis by Size and Status

Within Castor there are forty four listed buildings of all sizes. Only one of these, the church, is Grade I Listed and this is in the 'very large' category.

There are three small properties, eleven medium sized properties, seventeen large properties and seven very large properties that are Grade II Listed. Two large properties are Grade II* Listed.

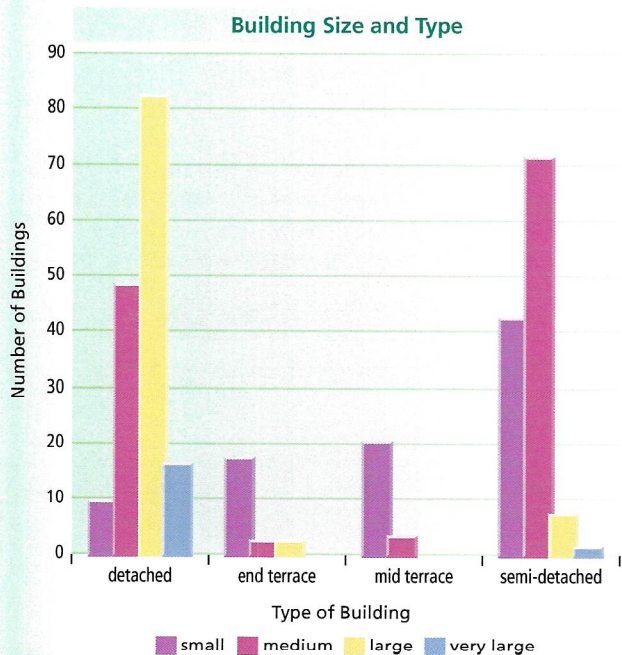
Analysis by Size and Type

Castor is clearly characterised by the presence of large and very large detached houses (eighty one properties), which account for one hundred and fifty one of the total number of buildings.

There are seventy one medium sized semi-detached houses; semi-detached properties account for one hundred and nine, (32.4%) of the total. There is one very large semi-detached property, seven large semi-detached properties and forty two small semi-detached properties.

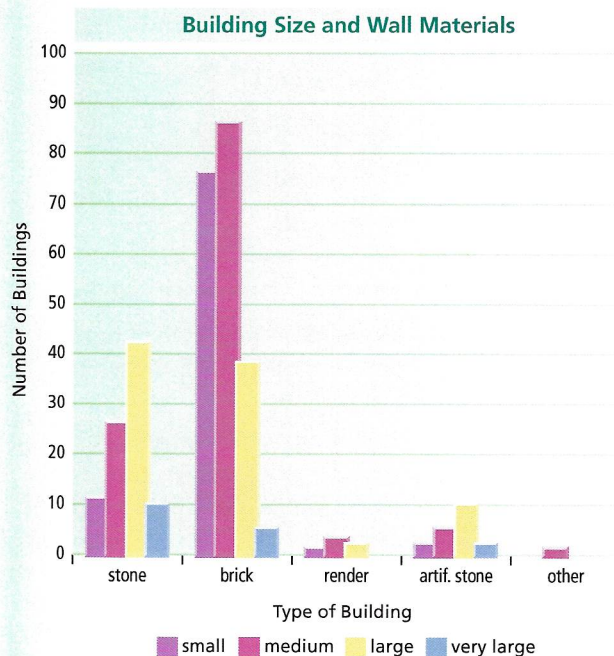
Analysis by Size and Wall Materials

Most properties of all sizes are built of modern brick. However, the greatest proportion of brick buildings are small and medium sized, whereas the greatest proportion of stone buildings are large.

It may be that the amalgamation of smaller stone properties has tended to increase the general size of stone dwellings. Nevertheless, Castor has a number of substantial stone houses including The Elms, Durobrivae House, Castor House etc. From the analysis of property size and age, it can be concluded that the 1950-1975 period saw a high proportion of brick medium sized houses built; the 1975-2000 period shows a higher proportion of small dwellings (reflecting affordable housing policies) and larger houses, denoting the rise of four to five bedroom properties with en suites, utility rooms etc.

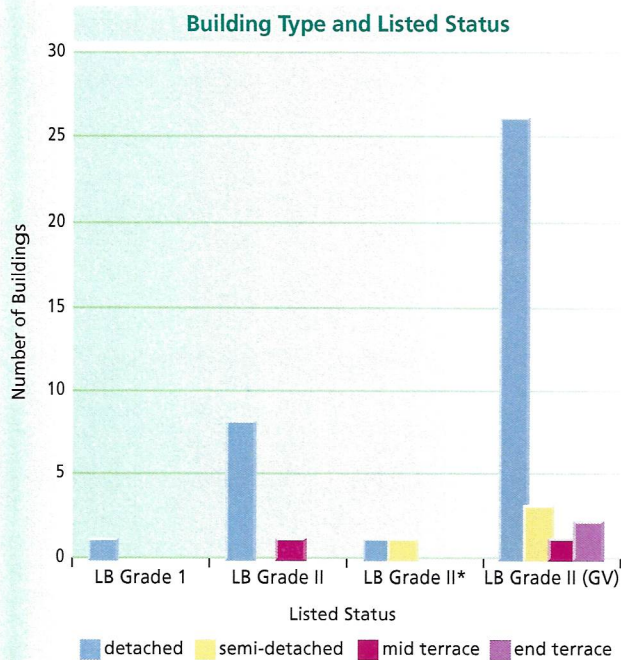
Analysis by Building Type and Status

Most listed buildings in Castor are detached properties. Of the few properties that are not detached, only four listed buildings are semi-detached, two are end terrace properties and one is mid terrace.

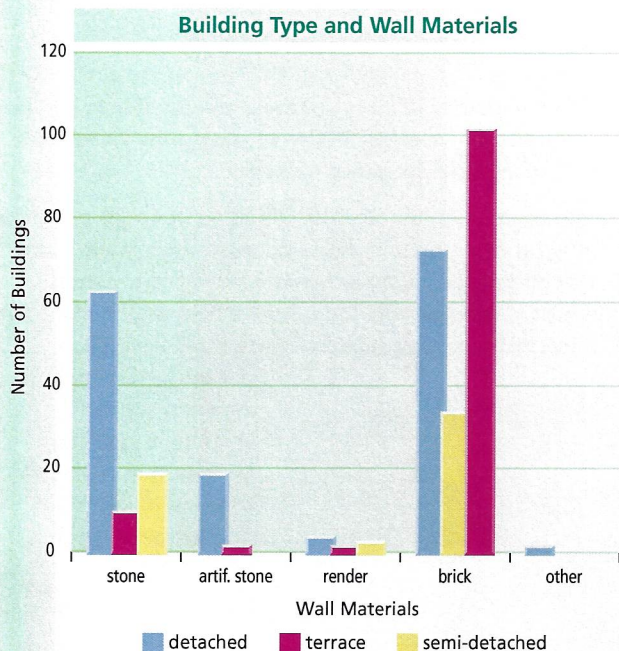
Analysis by Type and Wall Materials

Semi-detached properties built of modern brick are the largest category of buildings in Castor. The second largest sector is accounted for by detached buildings made of stone. Modern building materials account for a much greater proportion of the properties in the village than old materials.

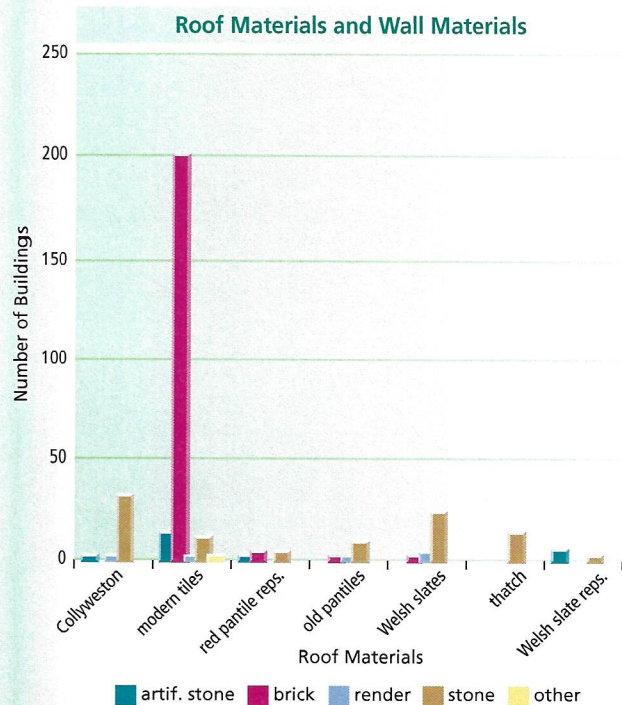
Analysis by Roof Materials and Wall Materials

The overwhelming majority of properties in Castor are made of modern brick and are roofed with modern tiles. This combination of materials accounts for one hundred and ninety nine properties in the village.

Stone properties with Collyweston slate roofs account for thirty one properties, while a further twenty three stone properties have Welsh slate roofs. There are thirteen stone properties with thatched roofs.

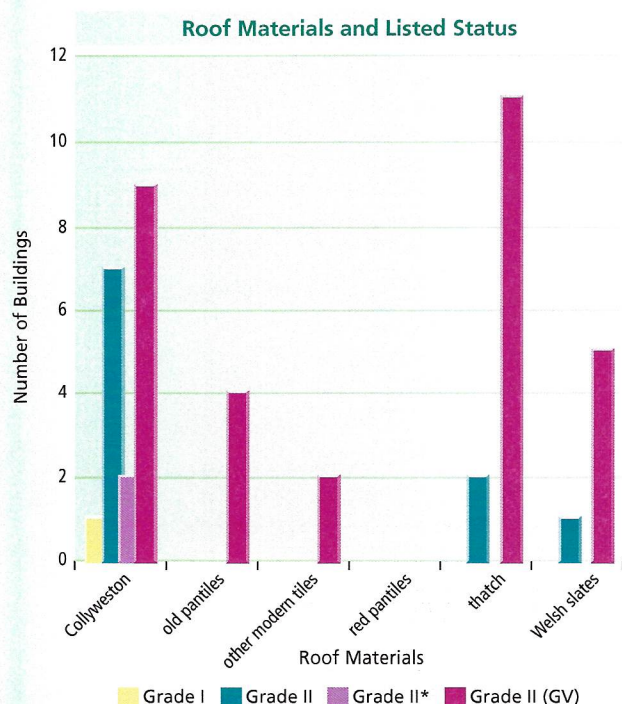
Analysis by Roof Materials and Building Status

The most prominent roofing materials on the listed properties are Collyweston slate and thatch – both traditional materials, and materials which particularly define the character of Castor.

Old pantiles are used on four Grade II listed buildings. Other modern tiles are used on two Grade II listed properties. Thatch is used on thirteen Grade II listed properties and one Grade II* property. Welsh slates are used on five Grade II listed properties and one Grade I listed building.

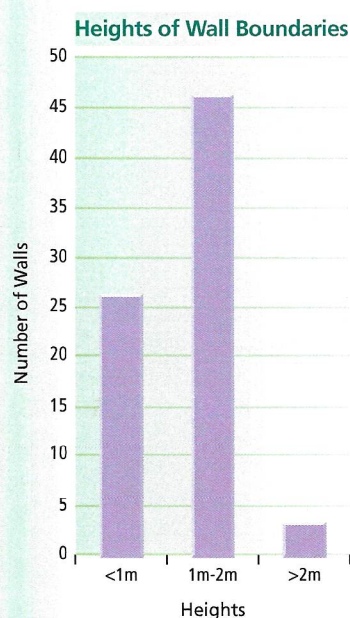
The actual number of walls which relate to properties is difficult to accurately assess because some walls span several property boundaries but are relatively short, whilst others are very long, have a big visual impact and only relate to one property. Many walls have been

punctuated by new access ways and sections which have been rebuilt. This has resulted in different heights, styles and relationships to properties.

Similarly, the village's stone walls need to be retained, kept in good repair and further breaches to create new access drives etc. strongly opposed. No new stone walls appear to have been built in the twentieth century. There are situations where new walls would enhance spatial enclosure or improve townscape by replacing wooden fences, which are less positive in the street scene.

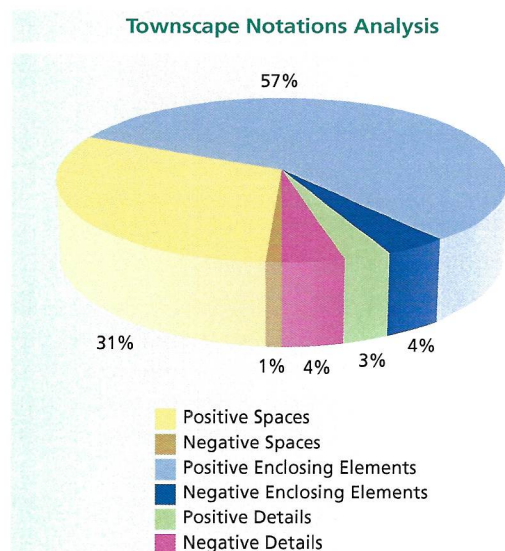
The townscape of Castor is overwhelmingly positive. A total of two hundred and sixty three positive and only twenty seven negative townscape contributions were recorded with a breakdown as follows:
