# CASTOR CONSERVATION AREA APPRAISAL REPORT AND MANAGEMENT PLAN

**Prepared by:** Planning Delivery Services, Peterborough City Council

**Date:** February 2008

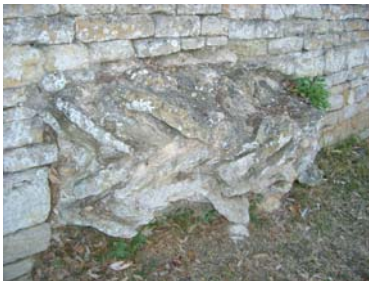
There were also substantial Roman structures on the current site of Castor village and characteristic Roman herringbone masonry can still be seen, for example in the bottom of the wall on Stocks Hill. (Photograph left)

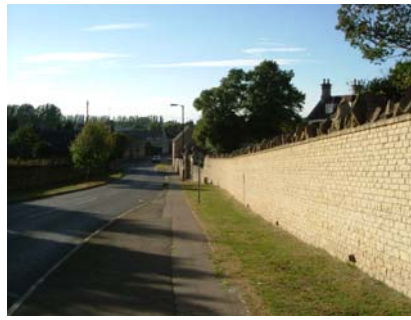
Boundary wall to Castor House

Travelling from Peterborough, the presence of the large houses, at the top of Castor Hill, give an indication of an approaching settlement. As the carefully constructed coursed stone wall to Castor House comes into sight, with the exotic tree belt behind, one is aware that there is a transition from landscape to townscape. When walking, the grass triangle to Mill Lane with planted trees, boundary fences etc obviously denote the outskirts of a settlement and after a few yards, the garages to 1 Church Hill focus into view, confirming the start of the village. Almost unexpectedly, the traveller plunges down Love's Hill until the road flattens out to suddenly enter in the strongly village setting of Peterborough Road.

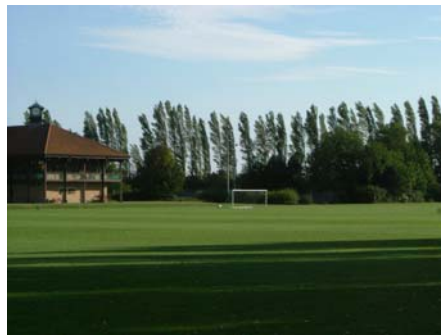
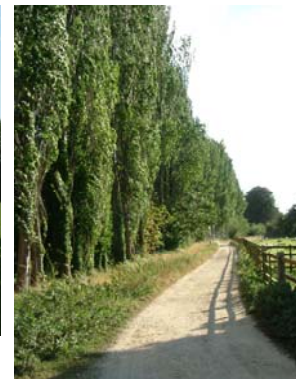
Poplar trees to sports field boundary.

The middle distance is dominated by the continuous row of poplar trees lining Splash Dyke from Splash Lane to Port Lane and the Pearl Sports Centre. The trees are alien to this landscape and almost totally obscure distant views of the village roofscape and church spire. The scale and proportions of the Sports Centre form a very dominant and none too sympathetic element in the landscape, at least in winter when the trees are not in leaf. However, they both give strong clues that beyond them, lies the village. This feeling is reinforced as the field paths converge toward the village and meet Splash Dyke, a clearly more strongly engineered structure. From Splash Dyke the 20th century boundary fences, conifer hedges and tarmac paths mark the arrival of the villages and this is confirmed by the presence of houses.

The need to plant trees to gradually replace 200-300 year old forest trees that are currently so important to the townscape and setting of the village has been noted. The unsympathetic nature of the rectangle of poplar trees surrounding the Pearl Sports centre site has also been considered. The desirability of avoiding planting that may damage archaeological remains (where these have not already been compromised), together with possible reinstatement of the extensive lines of mature trees that were recorded on the 1886-89 OS map.

- **As and when existing mature specimens need to be removed, for example, for reasons of safety, replacement planting of appropriate species should be carried out to maintain the character and appearance of the area. The main species should be selected from Cedar of Lebanon, Holm Oak, hybrid limes, DED resistant elms, beech and copper beech, oak and Scots Pine.**
- **In liaison with local residents and landowners the city council considers the possibility of removing the poplar trees surrounding the Pearl site and replacing them with a tree planting scheme that more satisfactorily assimilates the sports centre buildings into the landscape and, at the same time, frames key views of the village from the southern footpaths and vantage points.**

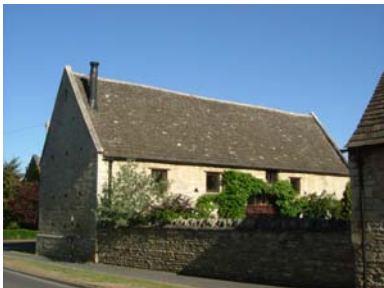
Former barns: Limes Farm

Historically, the farmsteads have comprised the farmhouse in close proximity to the barns, sheds and outhouses, generally forming the typically square "farmyard". Manor Farm, Village Farm, Home Farm and Hollies Farm were all once of this pattern. Today, only Hollies Farm remains in agricultural use; some farm buildings such as Home Farm have been converted to residential uses and part of the farm complex east of the village hall to business use, whilst others, notably the Manor Farm buildings, have been replaced by modern development.

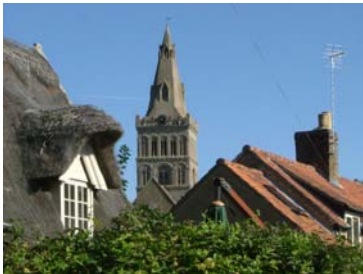
(left) Varied roofing materials

Until the 19th century the better quality houses were covered in Collyweston slate with lesser cottages and farm buildings being thatched in the long straw taken from surrounding fields. Today, 10% of roofs are still covered in Collyweston and about 4% of buildings retain their thatch. Almost all of these are on pre-1800 buildings.

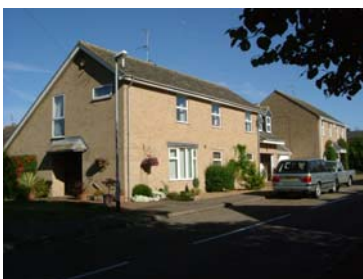
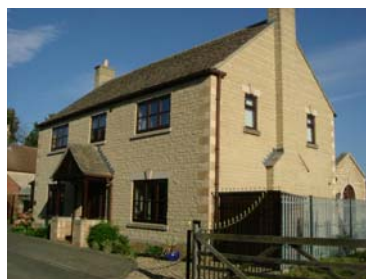
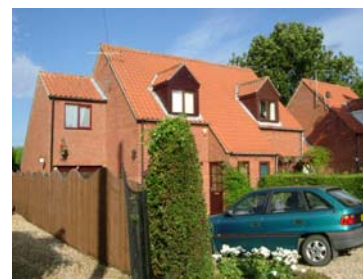
A major change occurred in the twentieth century. The industrialisation of the building industry and re-invention of concrete meant that large ranges of bricks and tiles were cheap and readily available. These new materials began to show in the 1930's (with the houses on Church Hill) but became overwhelming by the 1960's when all the new housing estates were constructed of modern machine made bricks and concrete roofing tiles. Today, modern tiles appear on 70% of all roofs and 63% of all walls are in modern brick. The choice of most of these modern materials has not always reflected the colours, textures or character of traditional local building materials

Modern materials at Manor Farm Lane, Splash Lane and Allotment Lane

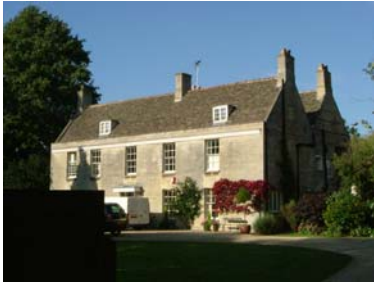
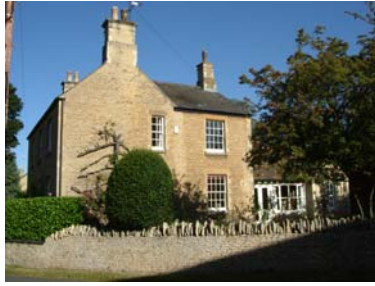
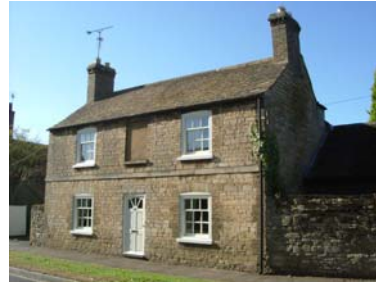
Squared rubble stone and dressed stone quoins, stone lintels (Collweston and slate roofs)

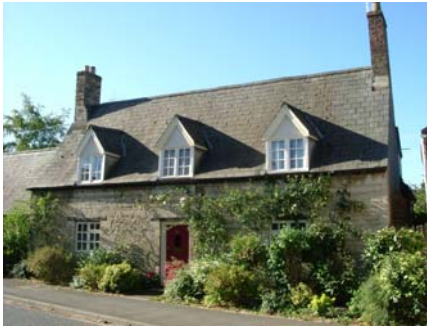
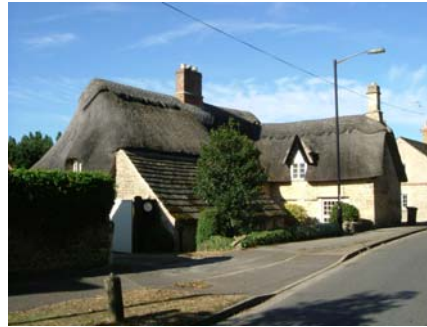
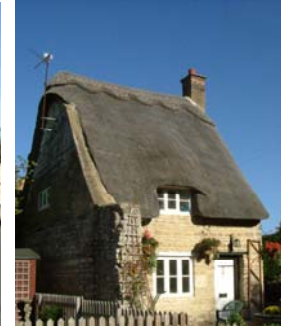
Lower quality rubble stone and rough dressed quoins with timber lintels

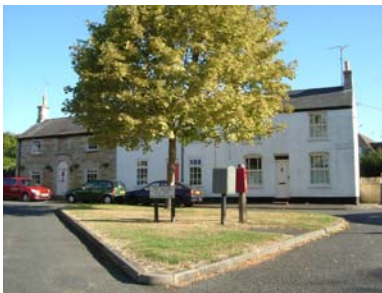
Rendered stone and slate

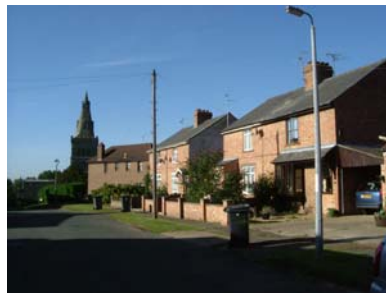
Modern brick and slate

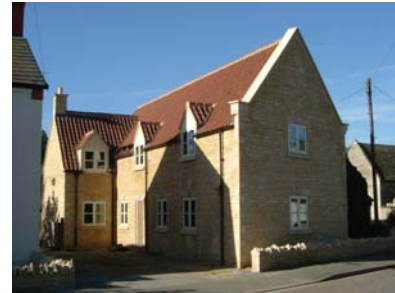
Recent stone faced and pantile

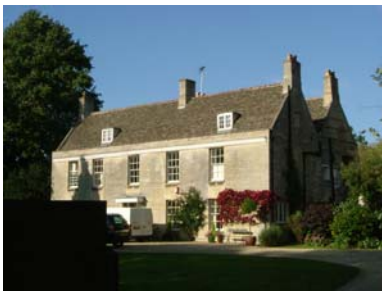
The Elms

The oldest secular building is Manor Farm, a 15th century stone structure with a classic "H" plan. The formal houses, The Elms, Durobrivae and Castor House date from the 18th century and have square plan forms with a "double pile" roof structure, covered in Collyweston slate; all have symmetrical 5 bay elevations with sash windows and classically influenced front doors and porch.

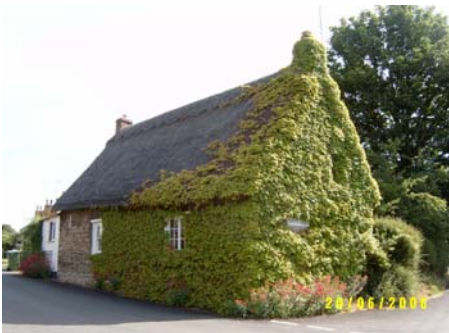
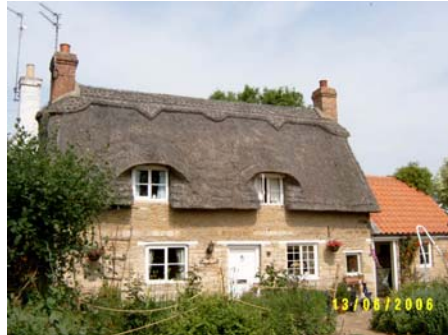
The typical vernacular form is a one and a half storey cottage, one room deep, with stone rubble walls incorporating squared stone quoins and plinths and a steeply pitched straw thatched or Collyweston slated roof with gabled ends. It would appear that the 'parapetted' gables date from the 18th century and, in some cases have been added to earlier structures (such as The Fitzwilliam Arms). The parapets are fairly crude and do not incorporate the kneelers, with carved details that are associated with much earlier structures.

Typical vernacular 1 ½ storey cottages

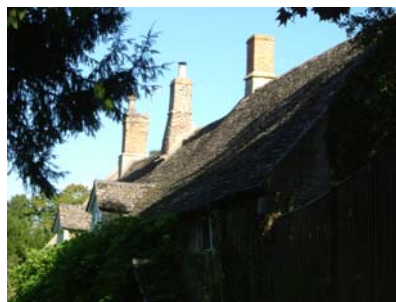
Chimney details

Earlier cottages and houses from the 17th century are most likely to have central stacks, whilst from the 18th century, end chimney became the norm. The brick shoulders to the central stack of 25 Church Hill are in brick that is clearly of an early date, with more typically 18th century bricks forming the chimney stack. It may therefore be that even in the 17th century, local red bricks were being used on the most vulnerable parts of chimneys. However, most 18th century buildings appear to have had square ashlar chimneys; many of the stacks have subsequently been replaced in brick with varying degrees of sympathy.

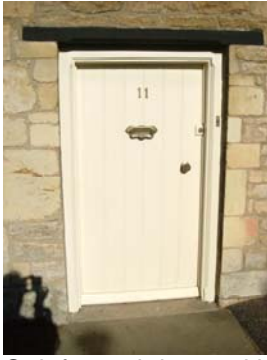
Cottage doors were invariably of simple plank construction placed centrally where there are windows either side of, or on one side of a 2 bay elevation. No 11 High Street and 25 Church Hill have 2 of the few 17th century plank doors that still survive, both in robust oak chamfered frames under an oak lintel. No 47 Peterborough Road has an ornate fielded panelled front door of the 17th century, with the lower half converted to plank construction, presumably at a later date. In some cases, and in most later (19th century) cottages segmental stone lintels are employed.

Oak framed doors with oak lintels

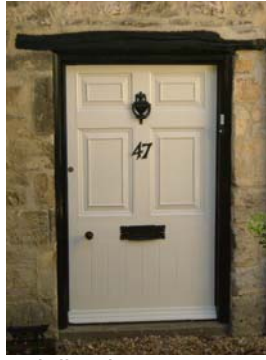
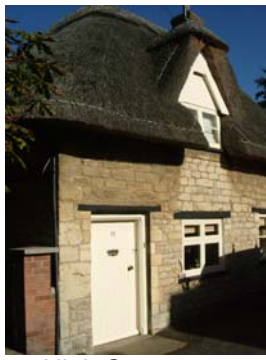
11 High Street

From 25 Church Hill and 11 High Street, it can be surmised that before 1800 most windows were constructed from substantial pegged oak frames with side hung leaded casement lights set on wrought iron hinges. This form of construction is consistent with the general locality.

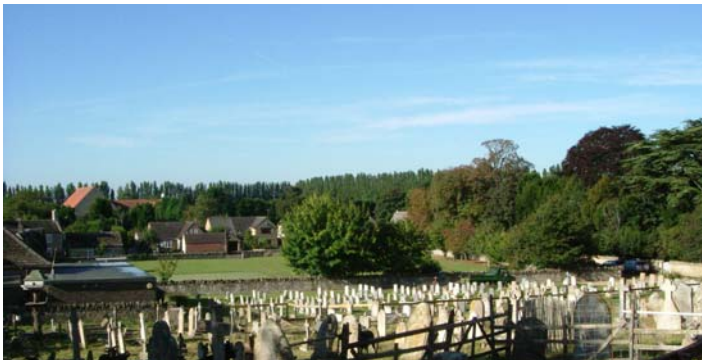
View of sports centre and poplar trees from church

Around the edges of the Sports Centre site (photo. left) are lines of Lombardy poplars, planted because they were considered to be suitable for a flat landscape. In reality, they form a fairly strident horizontal feature that dominates the landscape; from the south they do not screen the Pearl building but do prevent views of the church and village roofscape.

If one of the purposes of landscaping is to achieve some form of landscape conservation, there would be merit in carrying out more planting on field and dyke boundaries species that would have been present 150 years ago and to remove the poplars and replace them with a well considered tree belt similar, in conception, to the tree belts at The Cedars and Castor House which would not allow the roofscape of the sports centre to dominate the skyline but still give views of the church spire and village roofscape. Elms propagated from resistant stock should be considered. The 1886-89 OS map could be taken as a template for future planting.

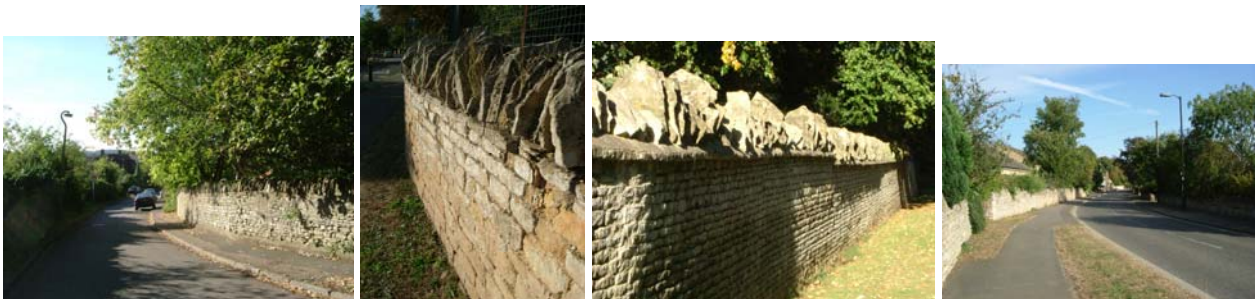
In later periods, walls for field boundaries tend to be far less well built and comprised of undressed stones laid in rough courses without mortar or hearting. These will have (and still do) required regular maintenance and rebuilding as part of the agricultural work cycle. This rough form of construction appears to have continued despite the high quality of local stone that lends itself to more permanent formal structures. A major change appears to have occurred in the 17th and 18th century when the landscaping of formal parks and gardens became a major industry. The great estates of Burghley and Milton appear to have pioneered the quarrying and dressing of local limestone and the extensive building of carefully coursed stone walls bound with a minimum of mud and/or lime mortar. Today, walls from these periods are a major element in Castor village. High quality walls form boundary enclosures to the more formal buildings, notably, the church, and Castor House, whilst slightly more informal walls delineate the boundaries of almost every property constructed before 1900. It can be expected that many currently existing walls have been built on the footings of earlier structures; the Rectory garden boundary wall on Stocks Hill can clearly be seen to be on an earlier Roman wall. Therefore, even if the walls are no more than 250-350 years old, they may mark ancient boundaries.

Major presence of stone boundary walls

Where alterations or extensions are planned for existing buildings it may be a requirement of that development that stone boundary walls are put into good repair using traditional methods and materials. On new development, the local tradition of stone walling should be continued by forming boundaries between private and public spaces and other appropriate boundaries with traditional constructed local stone walls.

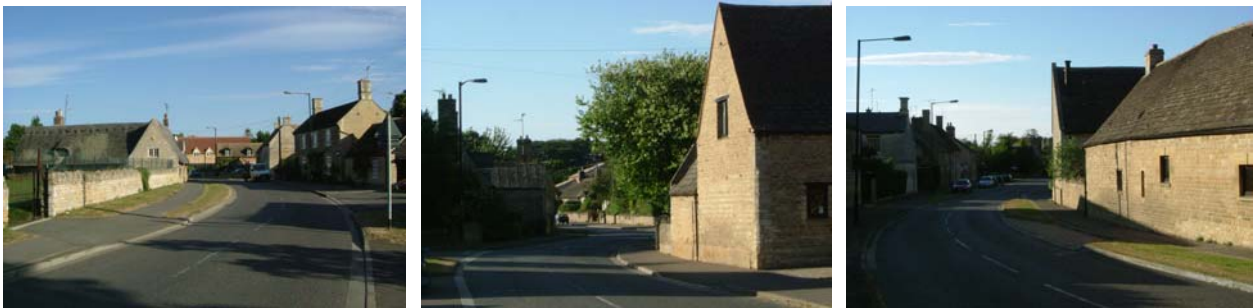
The building of gable ends close to the carriageway, bends in the road alignment, stone walls and trees forming visual 'pinch-points' that closed the view from one part of the road to the next. As one came to a 'pinch-point', one could gradually glimpse the next section of road beyond but it could not be fully seen until the pinch-point was passed. From here one could see the next space ahead, but views right down the road were interrupted by further visual 'pinch-points'.

Examples of buildings forming 'pinch-points' to closing views along Peterborough Road

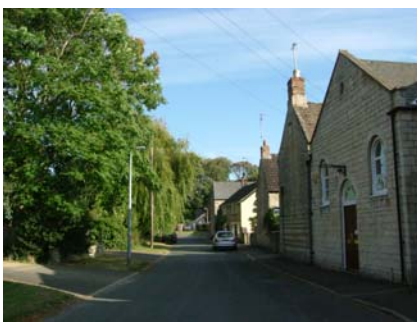
Church Hill

In other historic streets in the village core, this sense of transition from one small scale space to the next is apparent. However, in places the engineering of the carriageways with concrete kerbs, regularly spaced street lights and signs have lessened the historic sense of place.
