NEIGHBOURHOOD PLAN

BUILT ENVIRONMENT AILSWORTH 2016

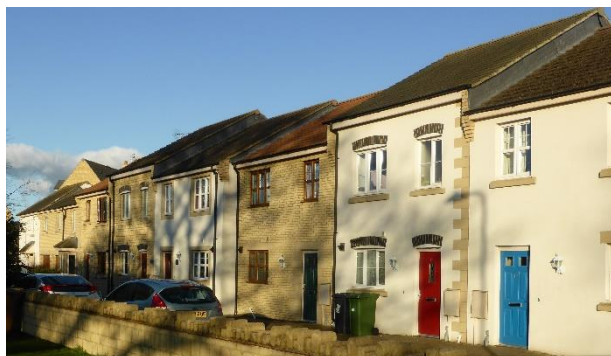
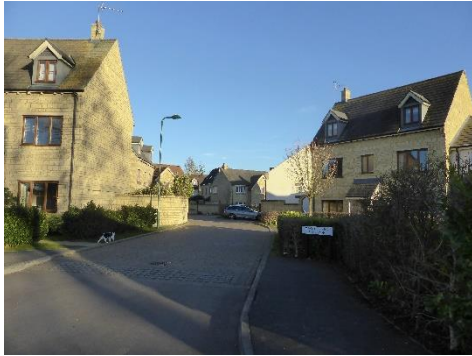
Entrance to Normangate

The Normangate development was built on a brown field site that was originally occupied by a lorry depot and a large barn. Although the building styles generally conformed to the requirements of the VDS (after several public meetings with the developer!) the density of the site is greater than that in the village in general, there is a disproportionate number of 2.5 storey dwellings (see table), and there are no footpaths or green spaces other than the frontage adjoining Station road and the private front gardens. However, the overall “feel” is good, with green open views from the perimeter of the development.

Boundary walls to the properties in Normangate are predominantly stone with stone “brick-on edge” capping and a drip course under. Those in Helpston Road and Peterborough Road are stone with traditional stone cock and hen capping, including a drip course in Peterborough Road but not in Helpston Road.

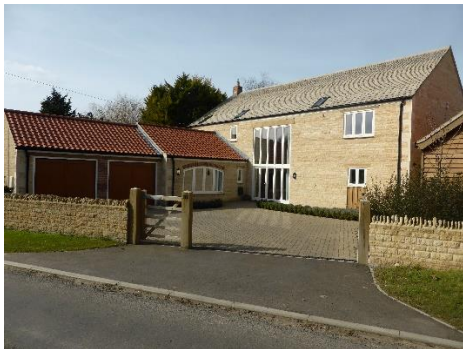
Helpston Road

- 3 are very large stone houses built in a field facing onto Helpston Road, No's 35, 37 & 39
- 1a Maffit Road is a brick built house on an infill site
- The old stables in Maffit Road have been converted and extended into a stone bungalow
- 1a Casworth Way is a brick built bungalow on an infill site
- 101A & 101B are stone houses built on a brown field site, previously a petrol station.
